# NETZSCH Spare Parts Midwestern Wastewater Treatment Plant

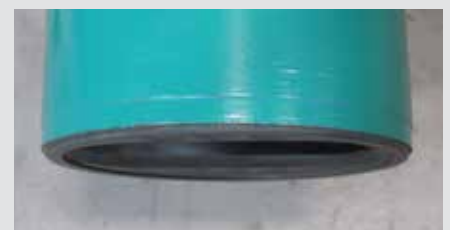
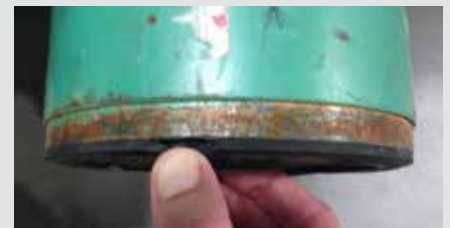
After receiving the faulty stator, several problems were immediately visible. Scratches, dings and rust were noted, even though the stator was virtually brand new, indicating a lesser quality product than a NETZSCH original part. Closer inspection confirmed that this stator was manufactured by a parts replicator. The stator had numerous internal fabrication differences, and non-standard measurements which had caused the pump's inability to start on its own.

Original NETZSCH part, top  
Pirate part, bottom

After checking their records, the customer confirmed that their plant had purchased the stator from a pirate manufacturer. The inferiority of the pirate part caused the pump's performance failure leading to the unnecessary expenses, labor, and operational downtime. Now, with a NETZSCH original part in place, the district's pump is operating quietly and smoothly, just as it had been designed to do for this application. This customer is happy to have all their NETZSCH pumps performing and running as they had come to expect. The NETZSCH team's quick diagnosis and solution helped significantly, and the customer says they will use genuine NETZSCH parts in the future.
